SITE NUMBER: WA-II-504

ADDRESS: 119 West Main Street, Sharpsburg, MD

Maryland Historical Trust
State Historic Sites Inventory Form

historic Christ Reformed Church

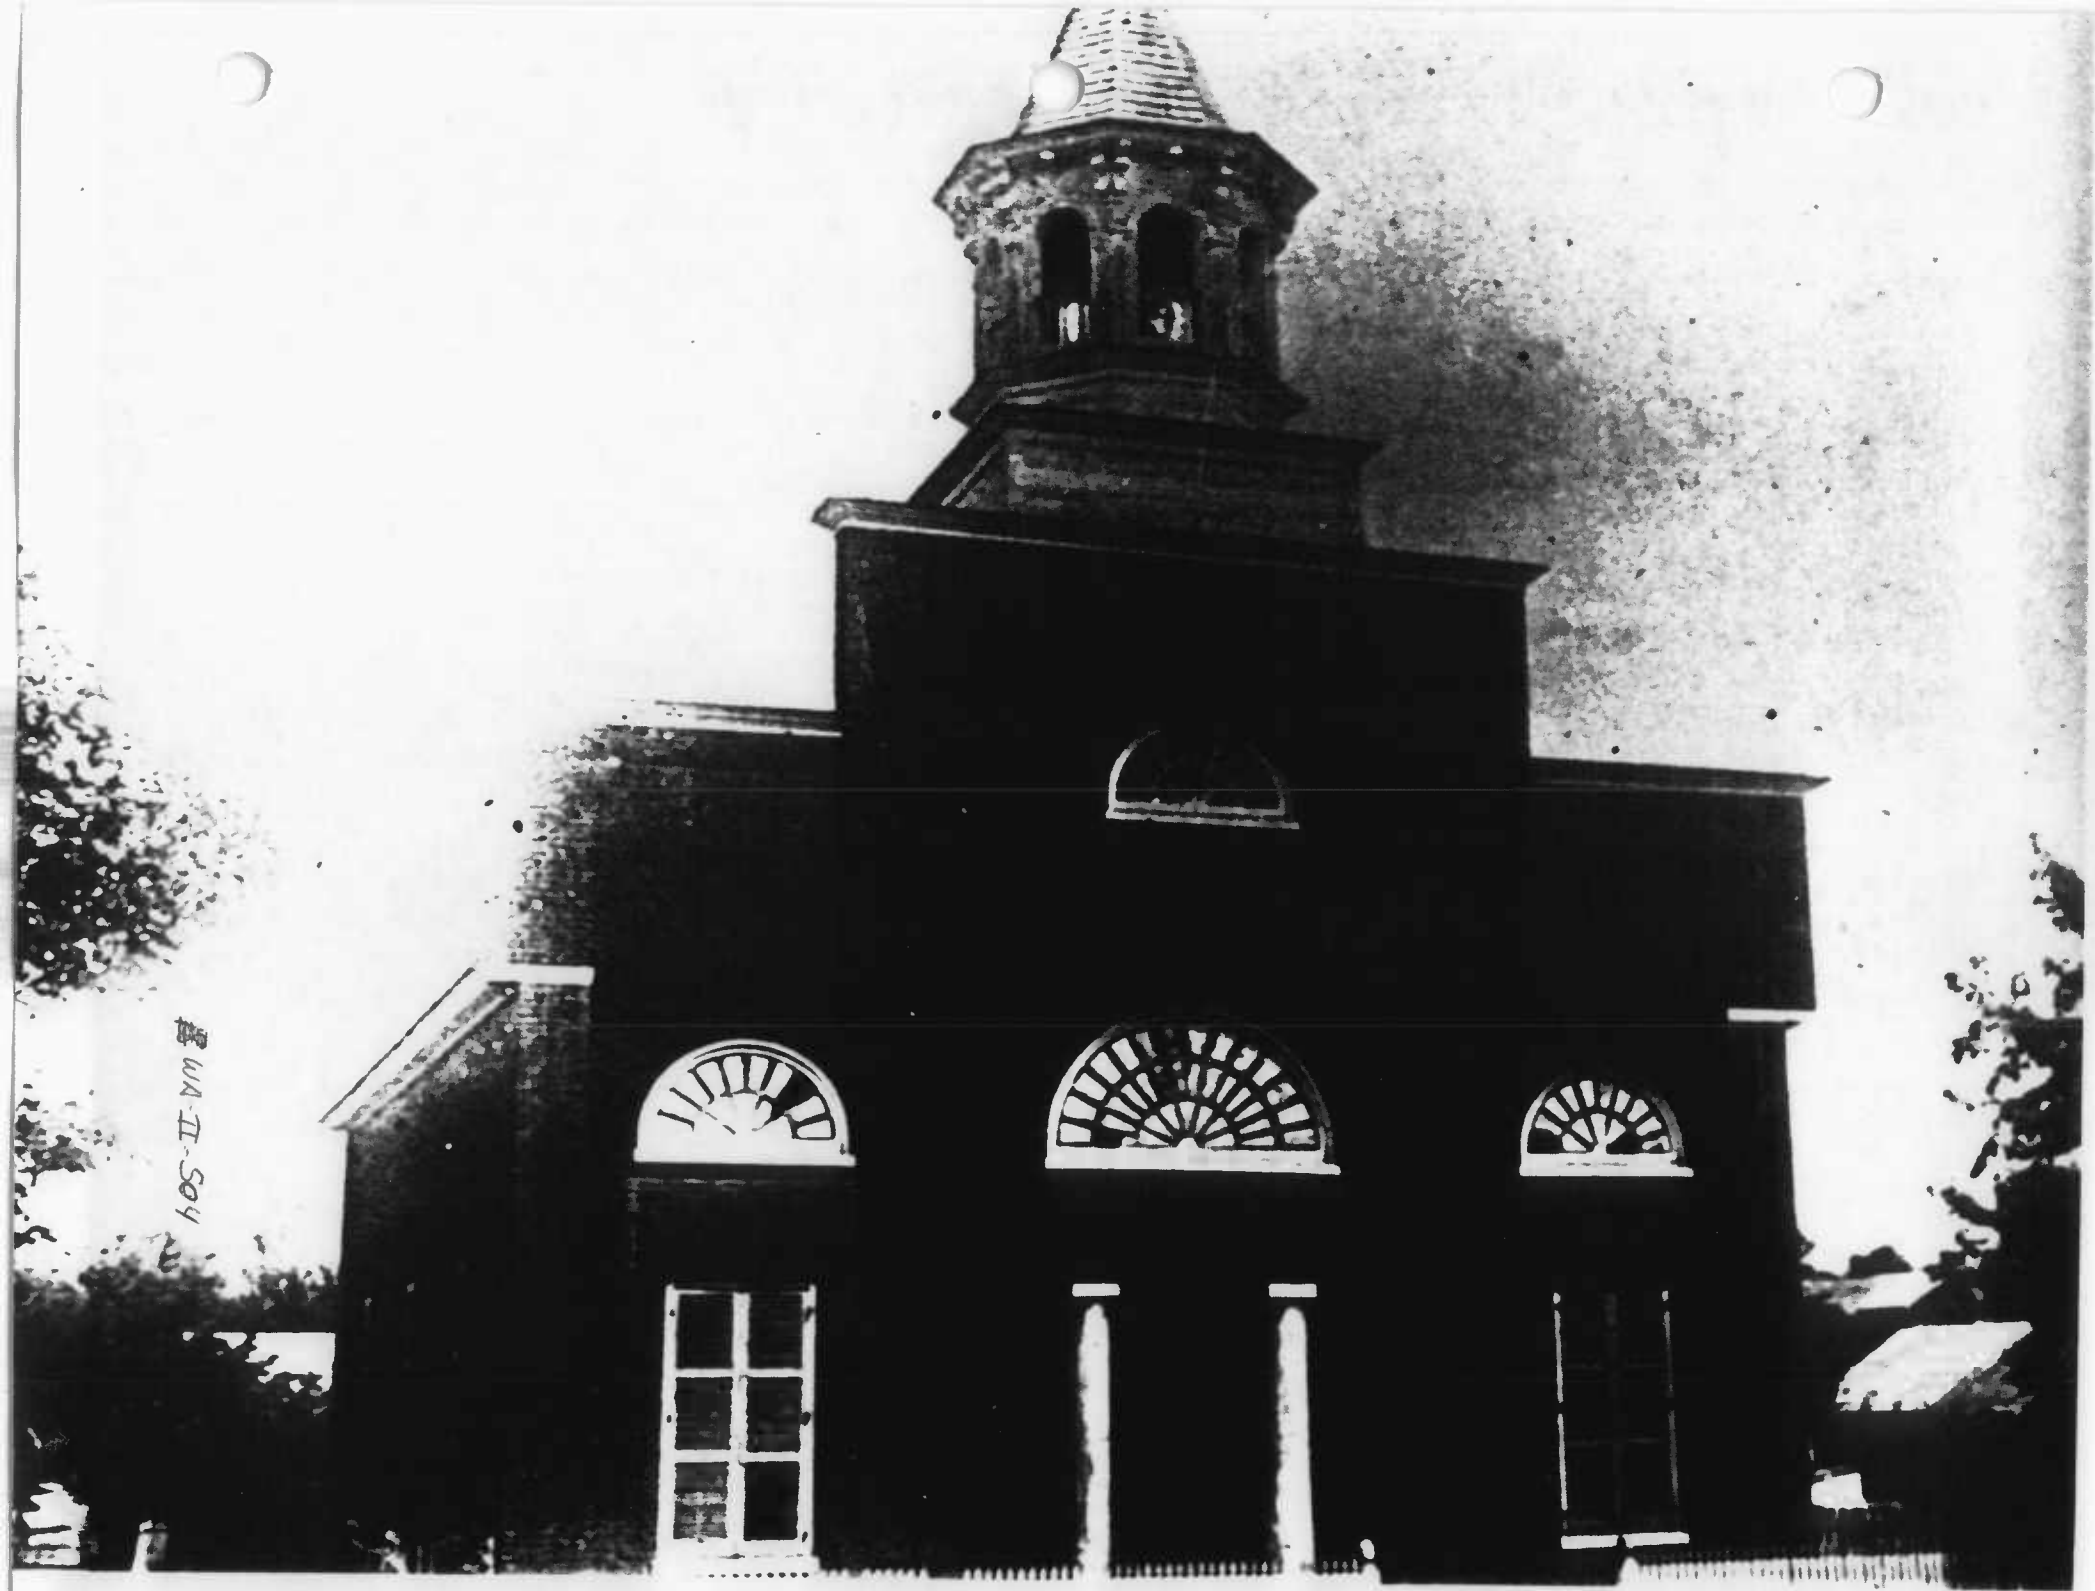
chun before civil war. Christ Church

The congregation moved to its present location on West Main Street in 1832 upon the completion of its new church at that site. The original church was demolished that same year. The new church is sited on original lot #46, whose first purchaser was George Keiffer (Liber J/Folio 135). The property was sold to the church by Mrs. Mary Ground. That building had a stepped parapet facade with a central entrance defined by two columns. Large windows were located in the flanking bays. Above the entry and the windows were large lunettes. A lunette also provided illumination for the balcony that served as a seating area for slaves and domestics. A massive frame cupola topped the structure.
